Improving Watershed Health at John Muir National Historic Site

John Muir National Historic site has recently completed a study to address erosion and flooding concerns in Strentzel Canyon. This briefing summarizes the issues and highlights some of the possible actions to improve watershed health.

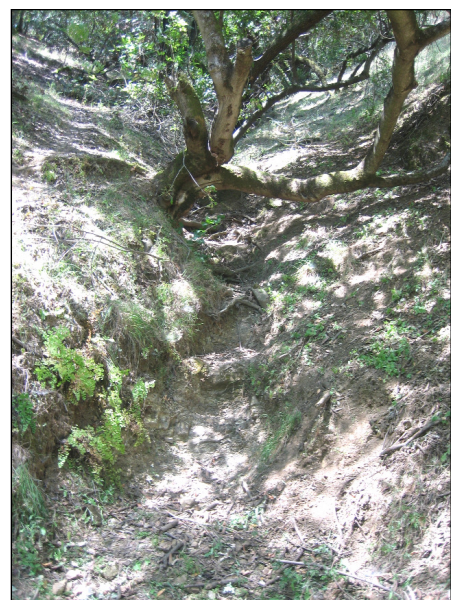
The network of ephemeral streams on Mt. Wanda carries eroded hillside sediment to the mouth of Strentzel Canyon, and Alhambra Creek.

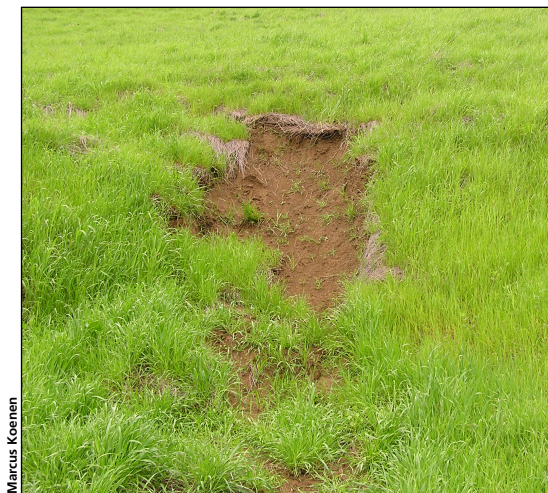
The shallow roots of non-native grasses accelerate erosion on Mt. Wanda. Dynamic creek channel erosion in the watershed and related downstream flooding prompted John Muir National Historic Site to begin a study that would determine the cause.

During the mid-1800s, the combination of the grazing pressure, disturbance by agriculture and drought forced a significant change in vegetation. Shallow-rooted exotic grasses replaced deep-rooted native bunch grasses. This shift in vegetation composition likely contributes to erosion seen today along ephemeral creeks in the watershed. The shallow roots of exotic grasses do not hold soil as tightly or hold as much water in the soil as the deeper roots of native grasses. The resulting increase in soil moisture allows precipitation to run more rapidly downslope, eroding the stream banks into deeply incised gullies.

The worst gullying is found on the north and east slopes. In some areas soil has eroded underground into small pipes that conduct water 0.3 to 1 meters below the soil surface. These can enlarge into tunnels or collapse to form a gully. Gullies are telltale signs of the hillside erosion and increased runoff that alter water quality, flooding intensity, vegetation dynamics and aquatic habitat.

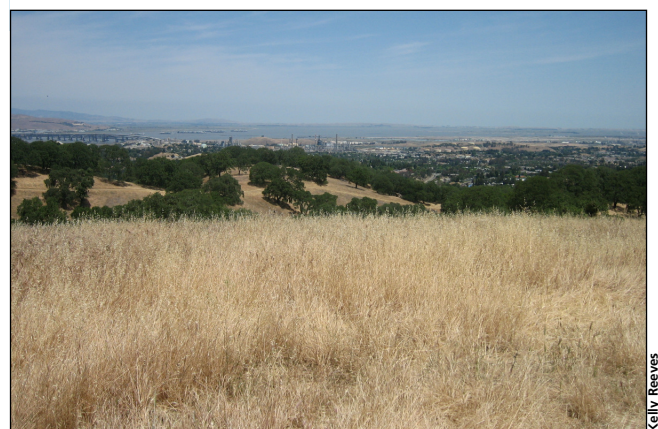
By the time John Muir strolled on Mt. Wanda, non-native grasses had replaced the native grasses. The vegetation shift likely contributes to the accelerated hillside and stream channel erosion seen today.
